## Project Note

Subject: Observations made by Tetra Tech personnel during a March 2006 reconnaissance of the Smokey Mountain Smelters facility in Knoxville, Tennessee

### PROJECT NOTE SUMMARY

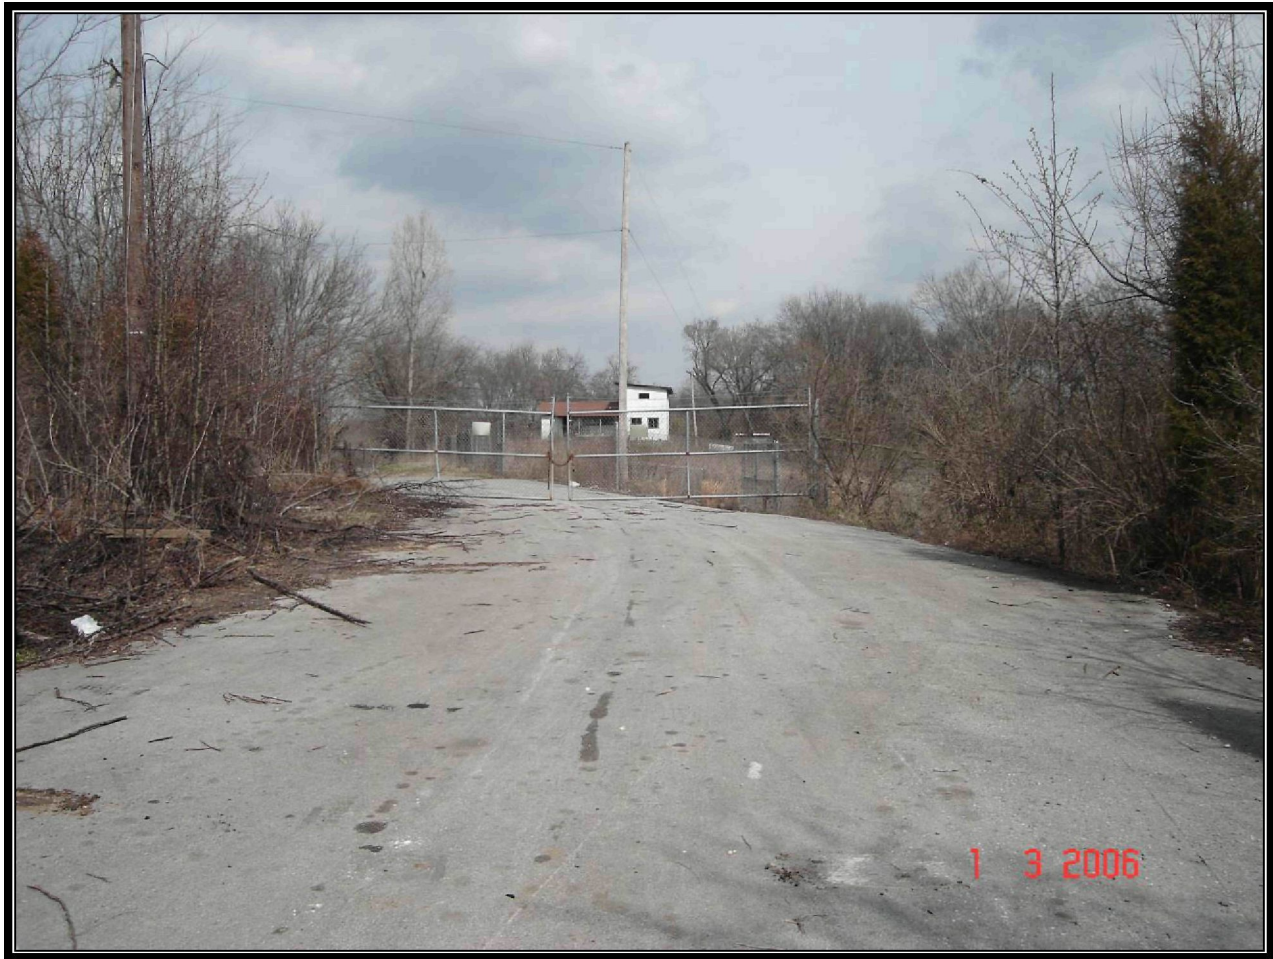
**OFFICIAL PHOTOGRAPH No. 1  
U.S. ENVIRONMENTAL PROTECTION AGENCY (EPA)**

<b>TDD Number:</b>	TTEMI-05-003-0001	<b>Location:</b>	Smokey Mountain Smelters (SMS)
<b>Orientation:</b>	West-southwest	<b>Date:</b>	March 1, 006
<b>Photographer:</b>	Sandra Harrigan, Tetra Tech	<b>Witness:</b>	Loften Carr, EPA
<b>Subject:</b>	Locked gate at the entrance of the SMS facility property.

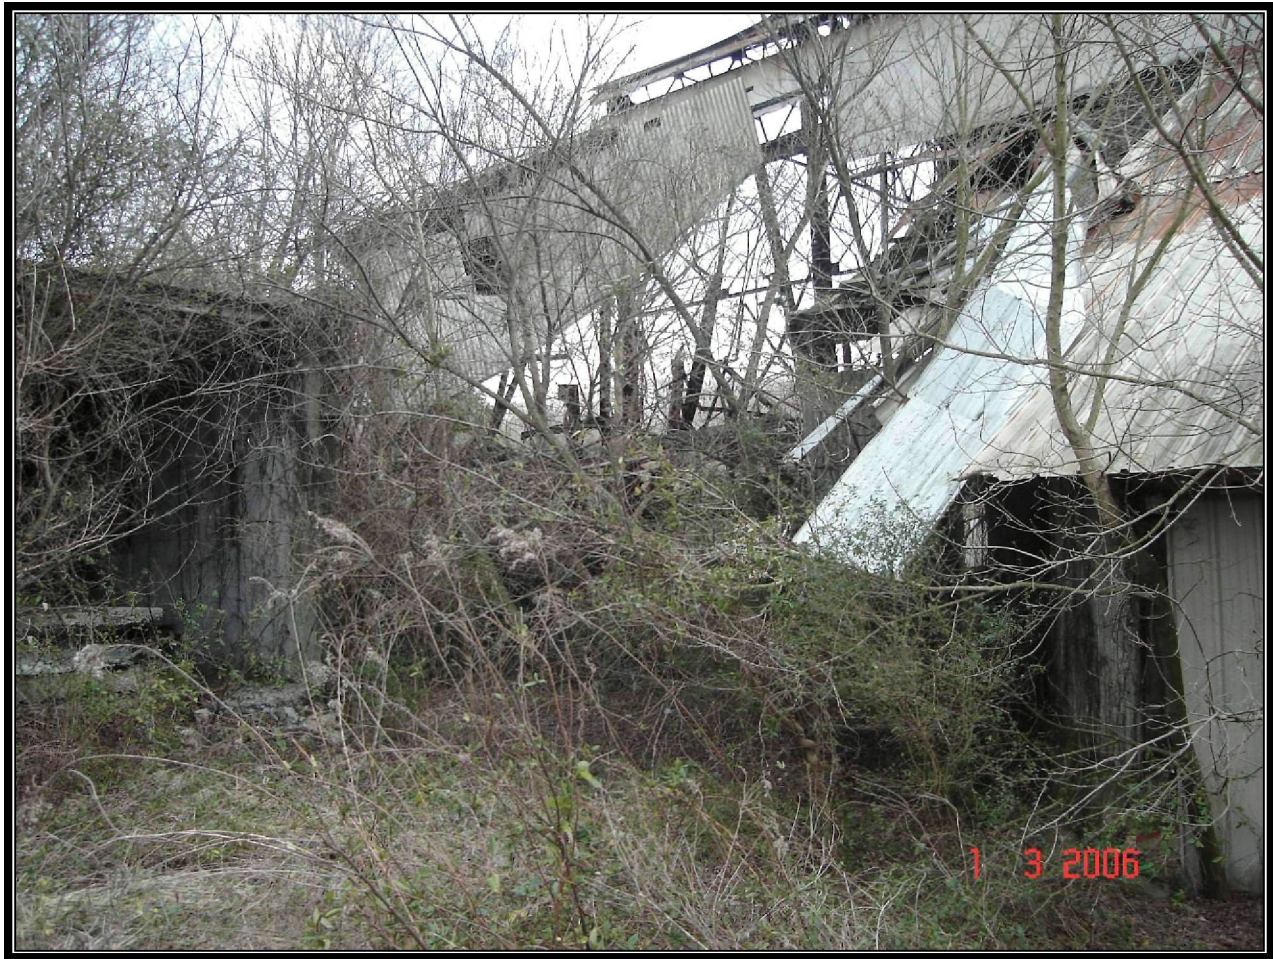
**OFFICIAL PHOTOGRAPH No. 2**  
**U.S. ENVIRONMENTAL PROTECTION AGENCY**

- The process building is made of corrugated steel and is in major disrepair. Many sections of the exterior walls of the building were missing or dilapidated. The roof of the building also was dilapidated, with many areas missing. In some areas, the corrugated steel looked as if it was about to fall off and would flap when the wind blew.

**Subject:** Dilapidated process building.

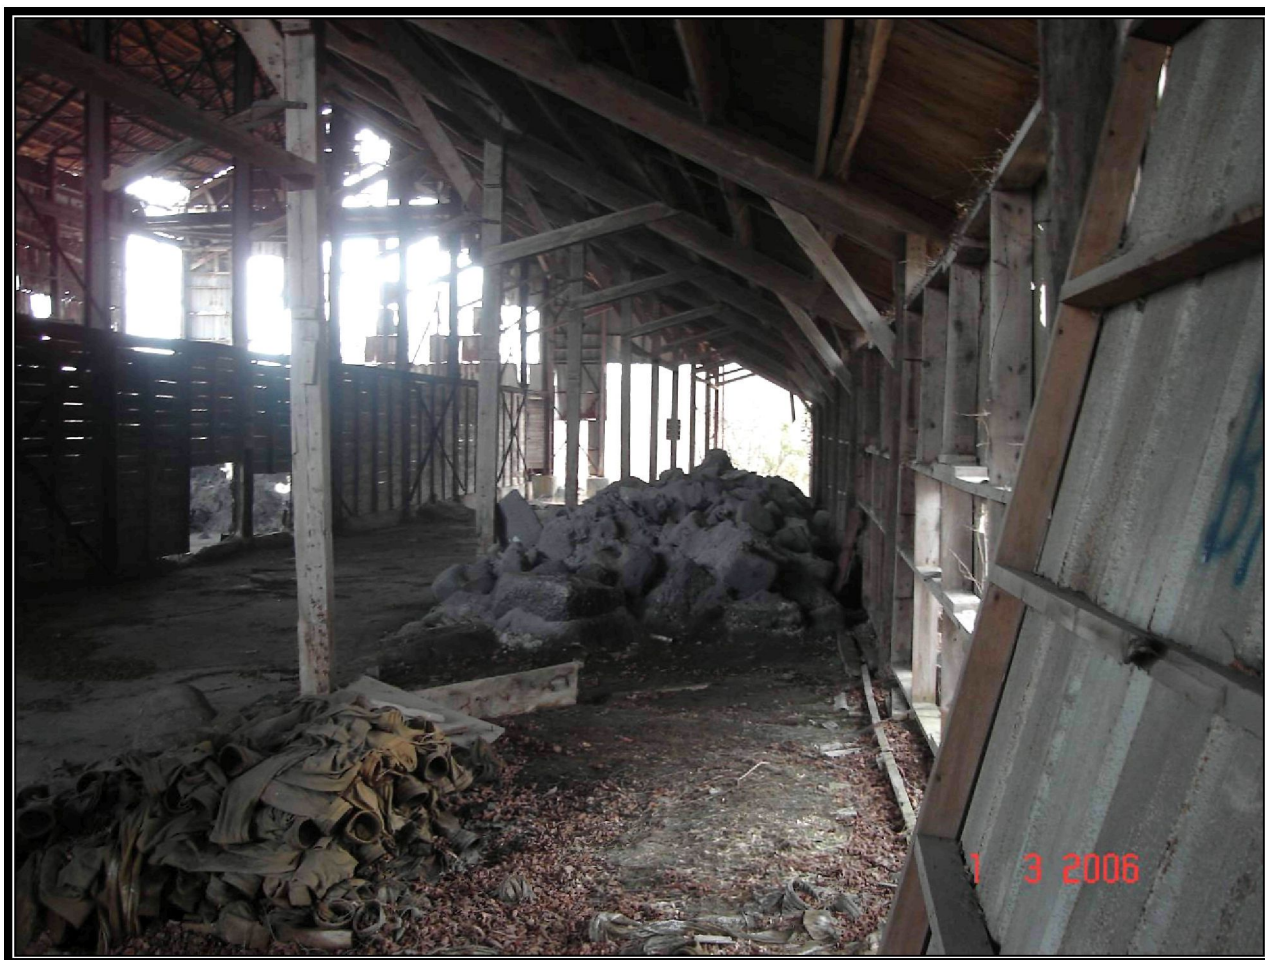
**OFFICIAL PHOTOGRAPH No. 3  
U.S. ENVIRONMENTAL PROTECTION AGENCY**

- The upper level of the building contained several piles of aluminum dross. The aluminum dross is gray in color. Some of the piles contained large boulder-like chunks with fine slag like material. Also, some piles appeared to be almost completely fine gray slag like material. In certain areas, the piles were almost to the roof.

**Subject:** Piles of aluminum dross located inside the process building. The roof and sides of the building are in major disrepair. Filter bags from the bag houses are located in the foreground of the picture.

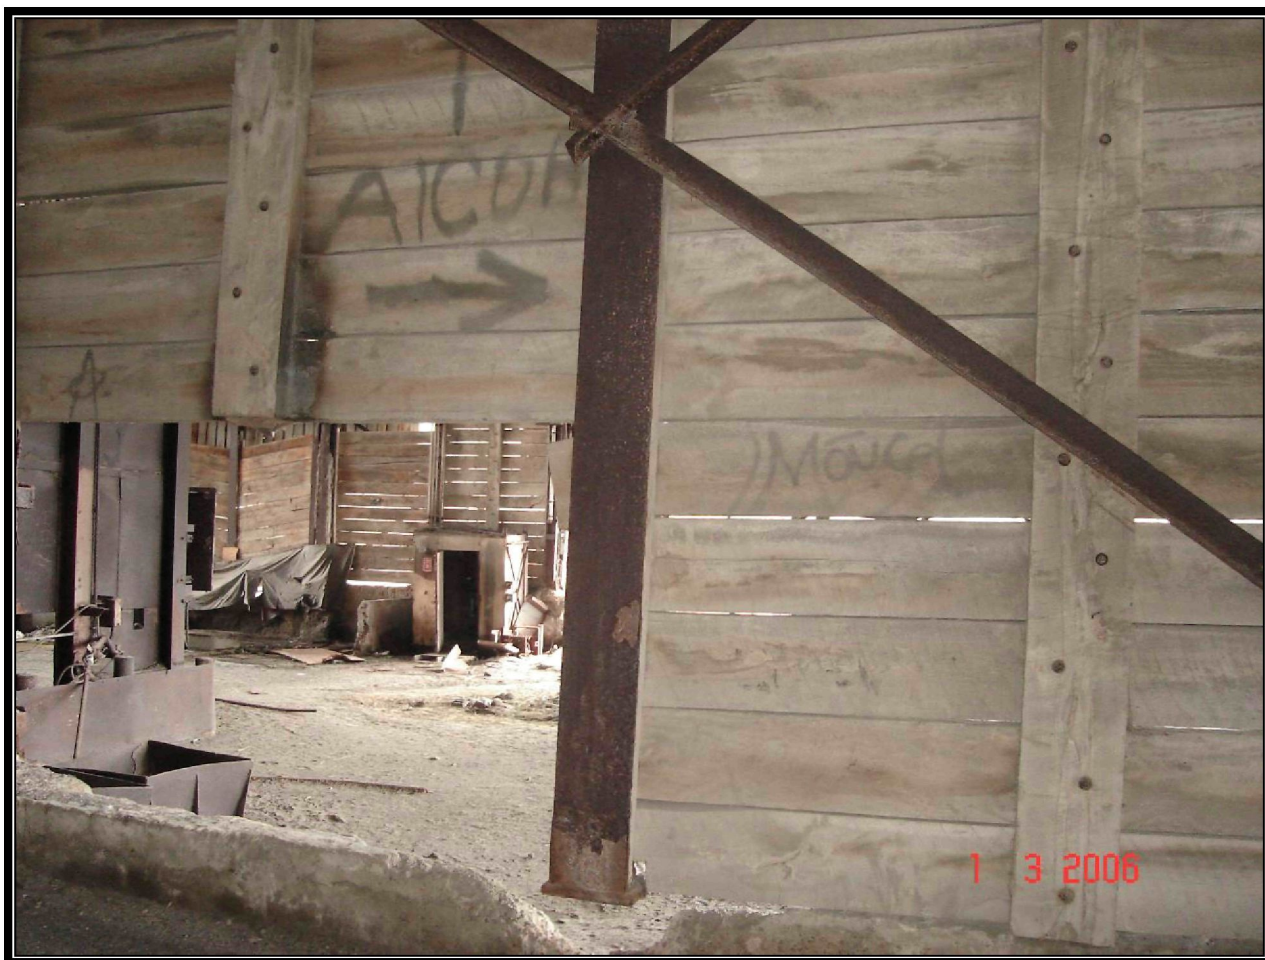
**OFFICIAL PHOTOGRAPH No. 4**  
**U.S. ENVIRONMENTAL PROTECTION AGENCY**

- The piles located inside the process building are referred to as interior waste piles.
- On the walls behind the piles, several words were written. The words appeared to be names of companies that may have disposed of waste at the SMS facility. Some of the names include: Alcoa, Metal Exchange, Meyers, Summit, and Emerson.

**Subject:** Inside of process building. Wooden partitions separate the upper and lower portions of the building. The names of companies such as Alcoa are spray painted on the walls of the building. These companies may have shipped waste to the SMS facility.

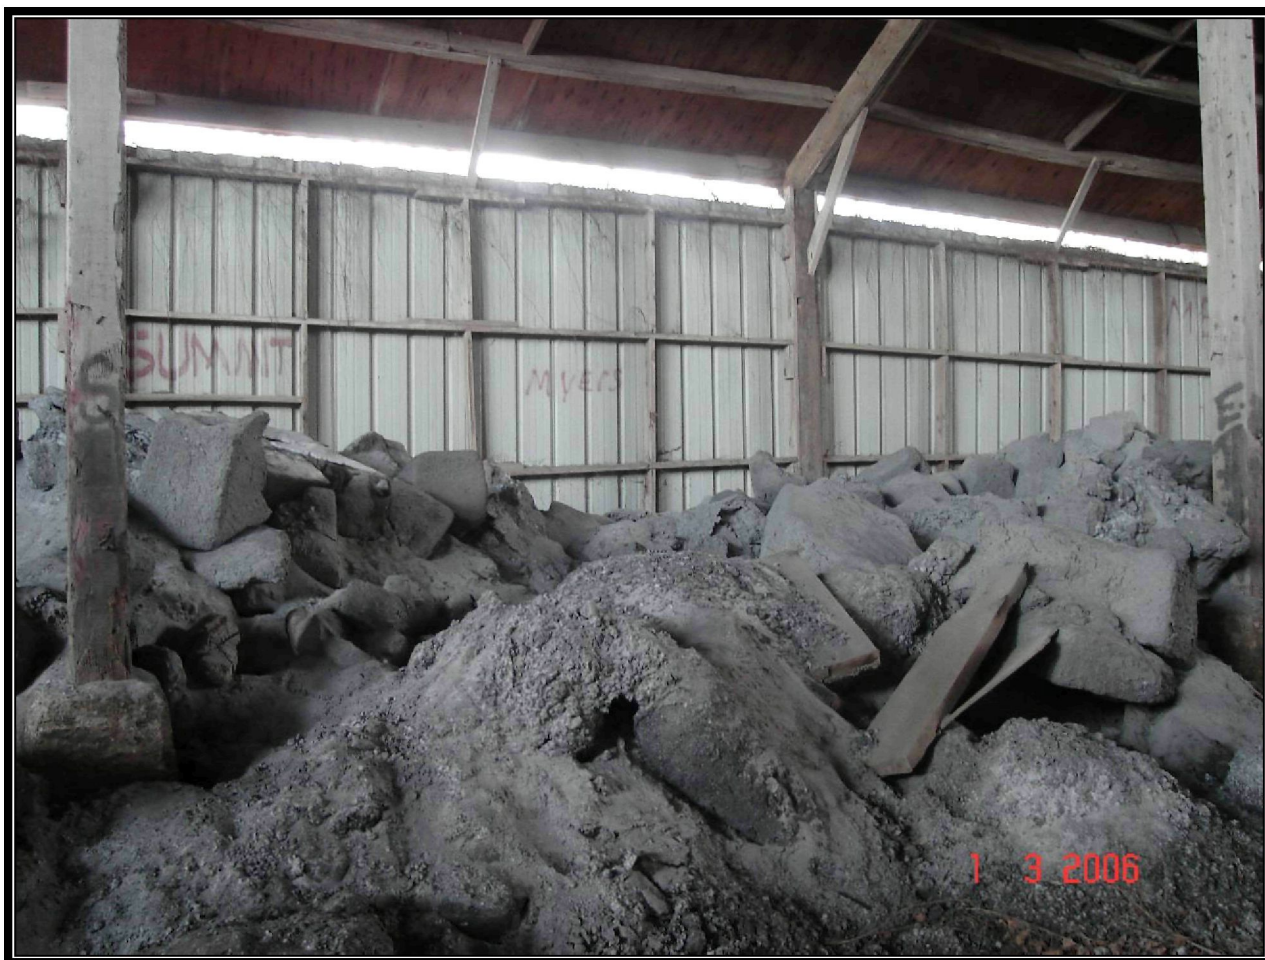
**OFFICIAL PHOTOGRAPH No. 5**  
**U.S. ENVIRONMENTAL PROTECTION AGENCY**

<b>TDD Number:</b>	TTEMI-05-003-0001	<b>Location:</b>	Smokey Mountain Smelters
<b>Orientation:</b>	Northwest	<b>Date:</b>	March 1, 2006
<b>Photographer:</b>	Sandra Harrigan, Tetra Tech	<b>Witness:</b>	Loften Carr, EPA
<b>Subject:</b>	Piles of aluminum dross located inside the process building

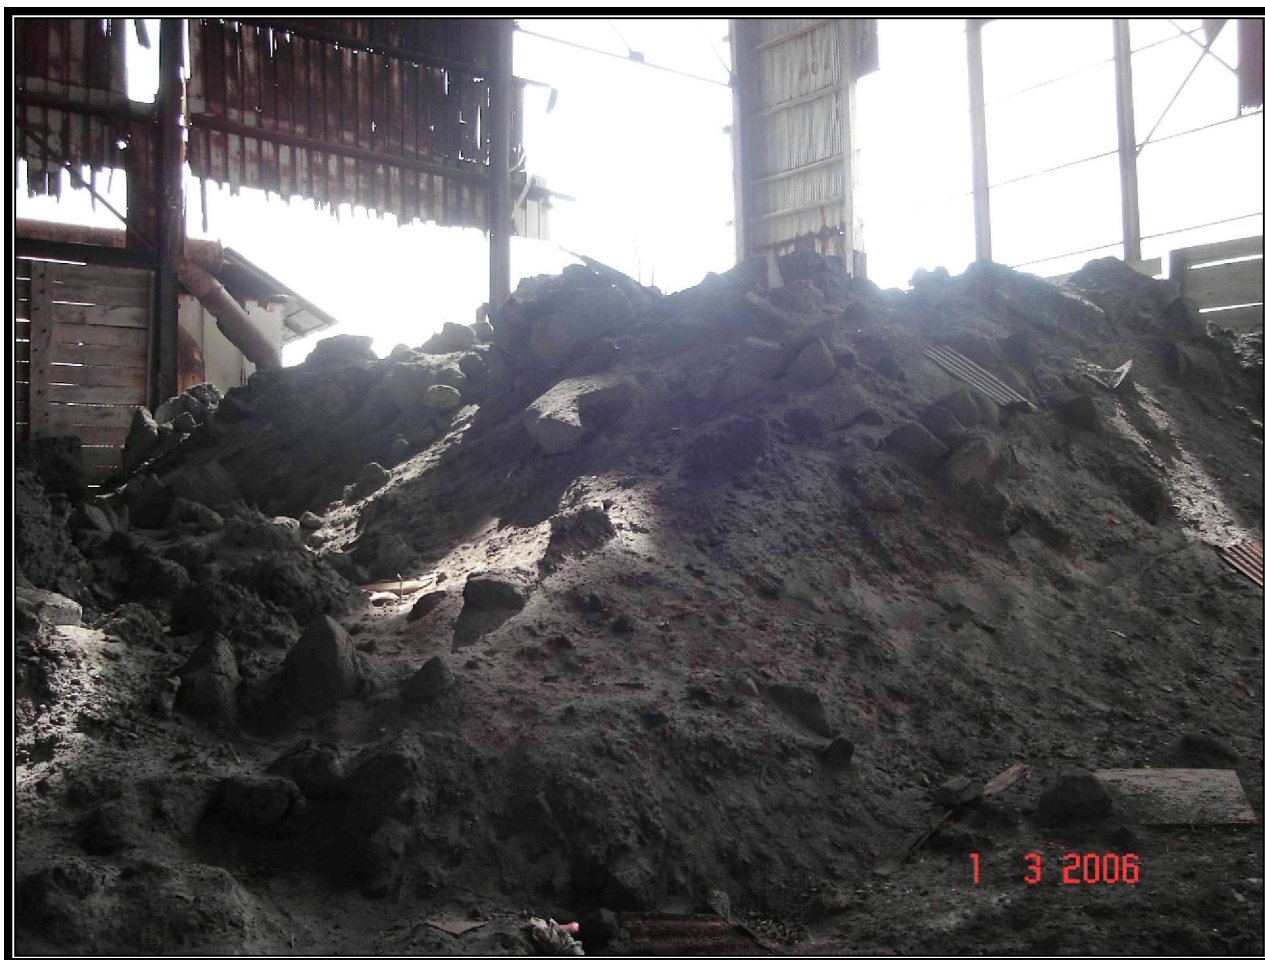
**OFFICIAL PHOTOGRAPH No. 6**  
**U.S. ENVIRONMENTAL PROTECTION AGENCY**

<b>TDD Number:</b>	TTEMI-05-003-0001	<b>Location:</b>	Smokey Mountain Smelters
<b>Orientation:</b>	East	<b>Date:</b>	March 1, 2006
<b>Photographer:</b>	Sandra Harrigan, Tetra Tech	<b>Witness:</b>	Loften Carr, EPA
<b>Subject:</b>	Large pile of aluminum dross located inside the upper level of the process building.

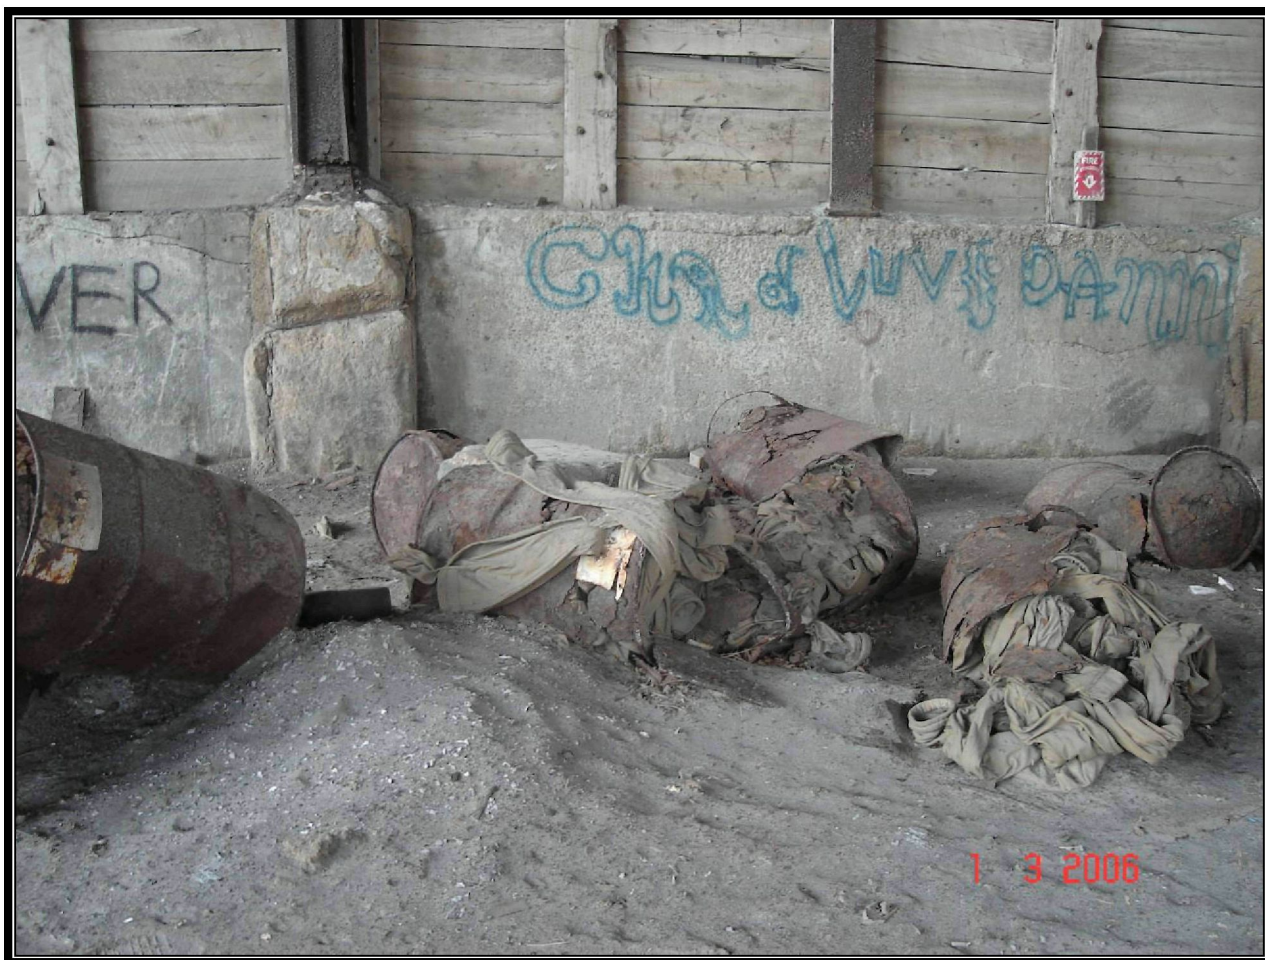
**OFFICIAL PHOTOGRAPH No. 7**  
**U.S. ENVIRONMENTAL PROTECTION AGENCY**

- Inside the upper level of the building, there were drums of what appeared to be filter bags from the bag houses.
- The lower level housed equipment that appeared to be some sort of mixer.

**Subject:** Aluminum dross located on the floor of the process building. Drums and what appears to be bags from the bag houses of the furnaces also are located throughout the process building.

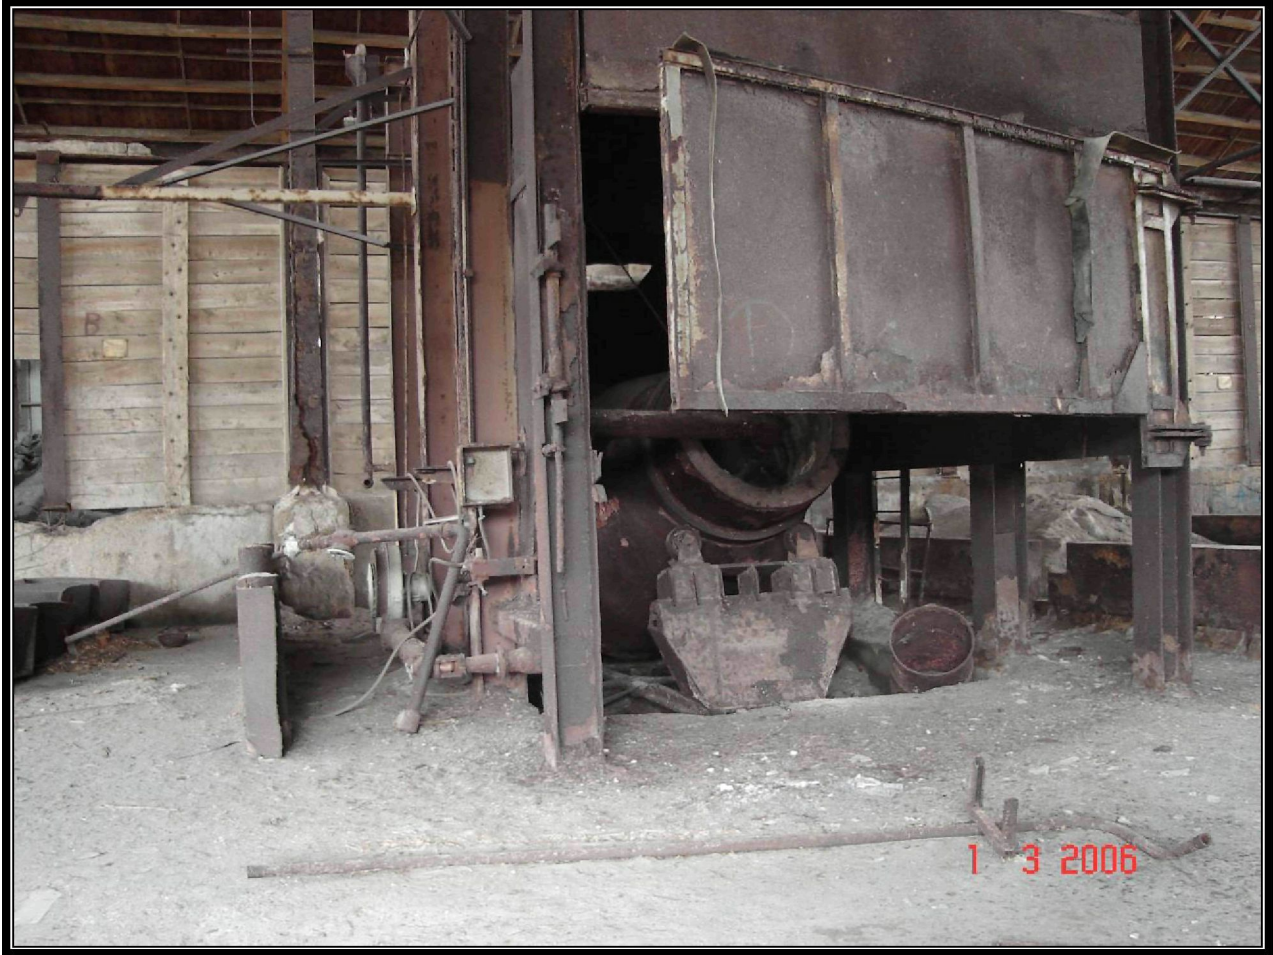
**OFFICIAL PHOTOGRAPH No. 8**  
**U.S. ENVIRONMENTAL PROTECTION AGENCY**

- The inside floor of the building appeared to be dirt and was covered with aluminum dross throughout.
- The inside of the building did not have many walls. There was a partial wall, which divided the building into upper and lower levels. There is a drop of about 10 feet between the upper to the lower levels of the building.

**Subject:** Lower level of process building. Lower level of process building is about 10 feet lower than the upper level of the building.

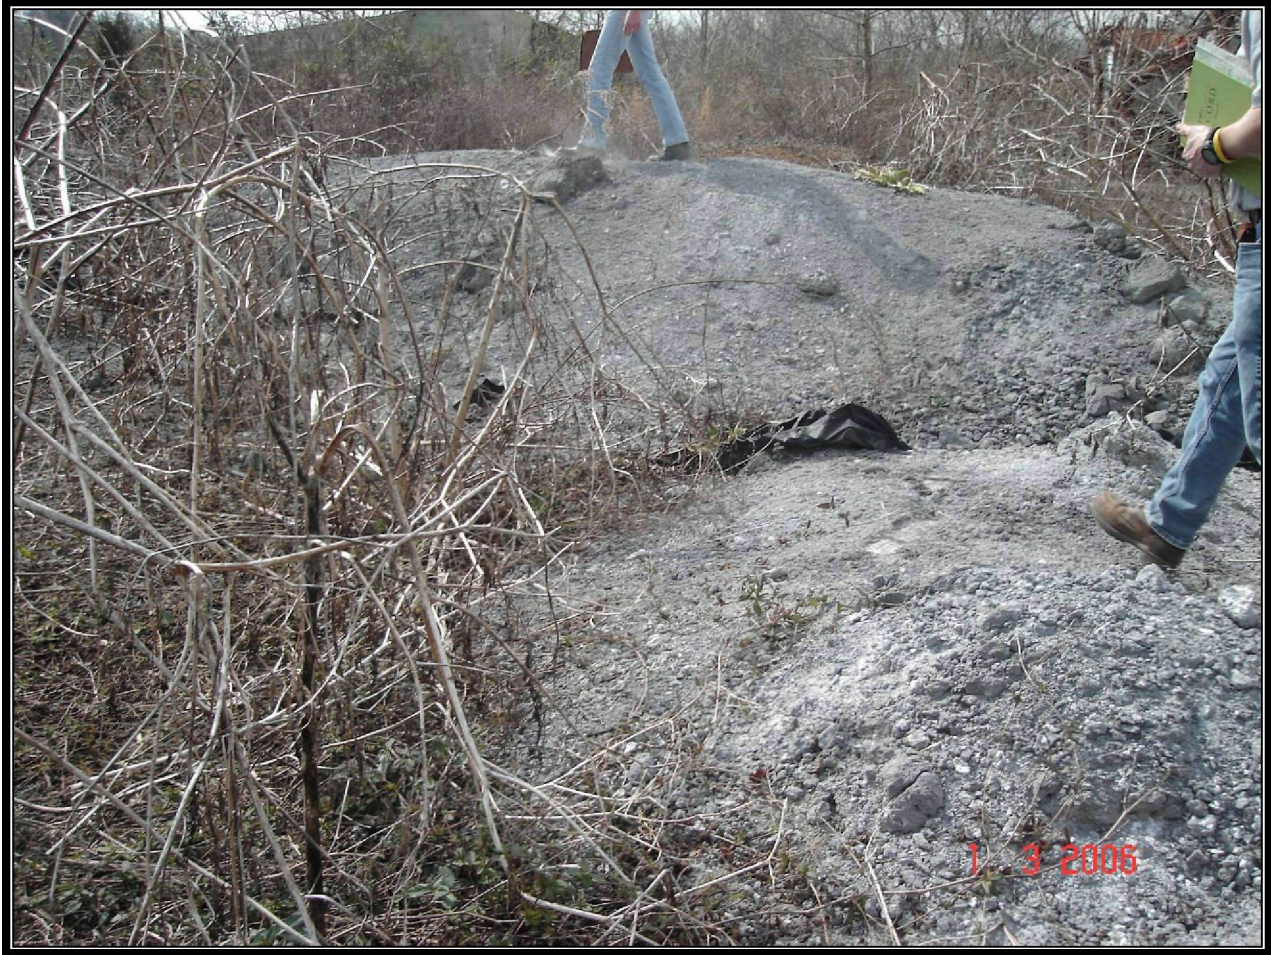
**OFFICIAL PHOTOGRAPH No. 9**  
**U.S. ENVIRONMENTAL PROTECTION AGENCY**

<b>TDD Number:</b>	TTEMI-05-003-0001	<b>Location:</b>	Smokey Mountain Smelters
<b>Orientation:</b>	Southwest	<b>Date:</b>	March 1, 2006
<b>Photographer:</b>	Sandra Harrigan, Tetra Tech	<b>Witness:</b>	Loften Carr, EPA
<b>Subject:</b>	Exterior waste pile located on the southern side of the process building

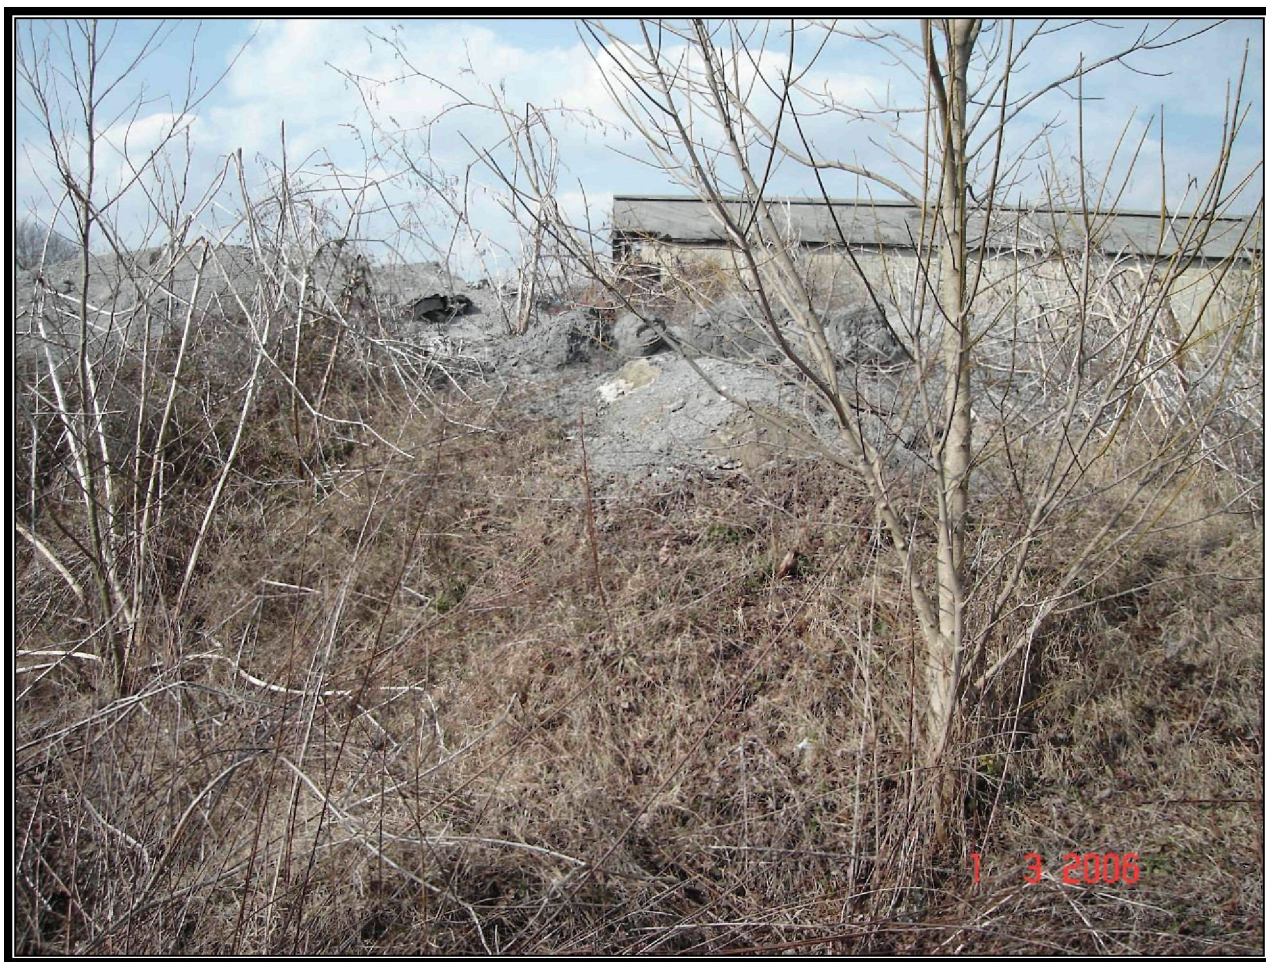
**OFFICIAL PHOTOGRAPH No. 10**  
**U.S. ENVIRONMENTAL PROTECTION AGENCY**

- A depression located south of the process building identified during the 1998 TDEC site investigation was not observed.
- The large exterior waste pile appeared to be the same material as the interior waste pile, but it appeared more weathered.

**Subject:** Exterior waste pile. The on-site process building is visible in the background. The enormity of the pile also is discernible based on the height of the pile in the distance.

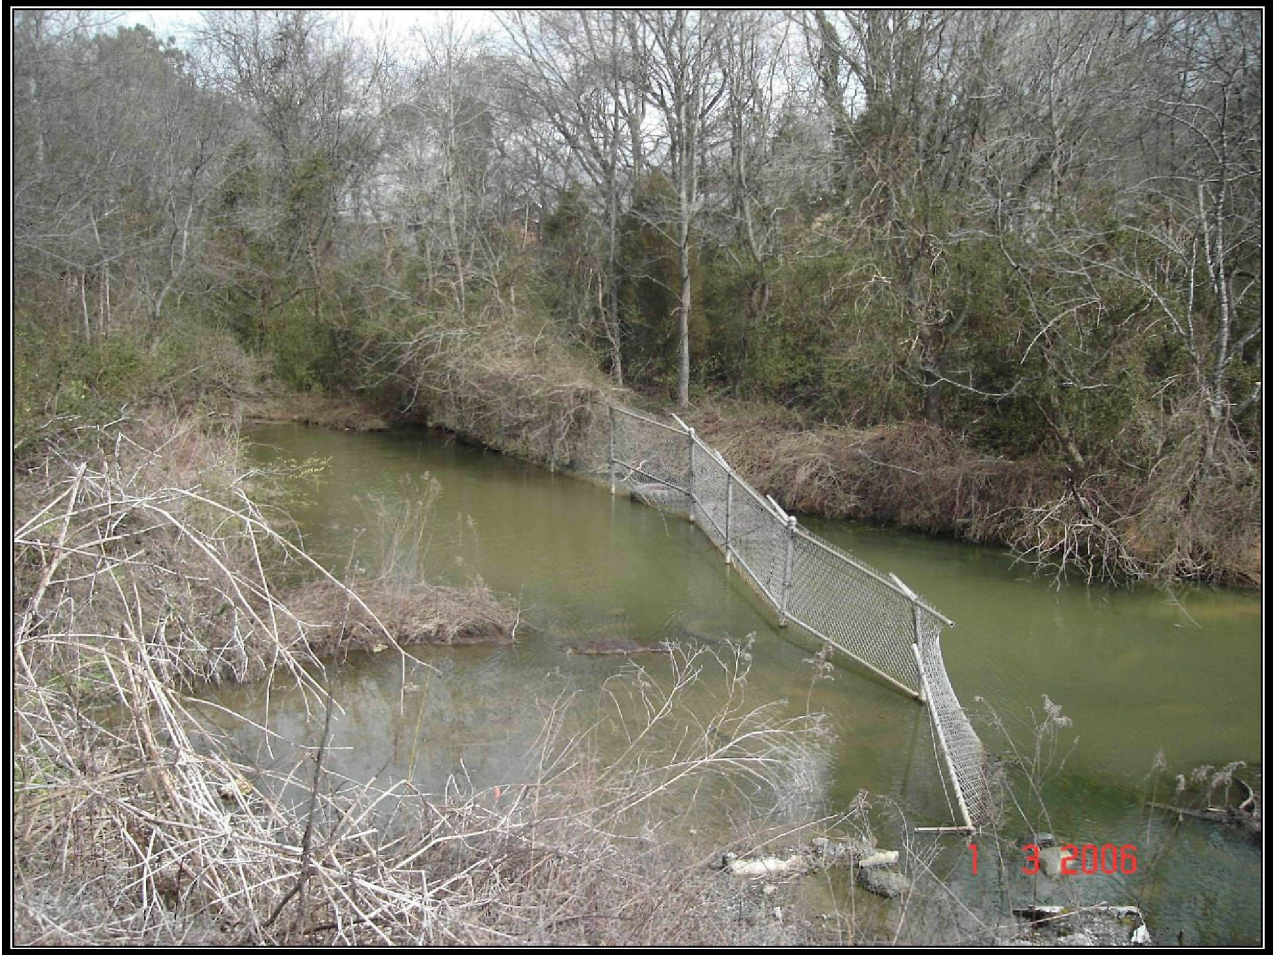
**OFFICIAL PHOTOGRAPH No. 11**  
**U.S. ENVIRONMENTAL PROTECTION AGENCY**

- A pond is located in a topographically depressed area in the eastern portion of the property. Mr. Maupin indicated that at one time, the pond was covered with aluminum dross from the waste pile located on the southern portion of the property (exterior waste pile). This pond is sometimes referred to as a settling pond. A fence was located in the pond.

<b>TDD Number:</b>	TTEMI-05-003-0001	<b>Location:</b>	Smokey Mountain Smelters
<b>Orientation:</b>	East-southeast	<b>Date:</b>	March 1, 2006
<b>Photographer:</b>	Sandra Harrigan, Tetra Tech	<b>Witness:</b>	Loften Carr, EPA
<b>Subject:</b>	On-site pond. Located in the east-central portion of the SMS property.

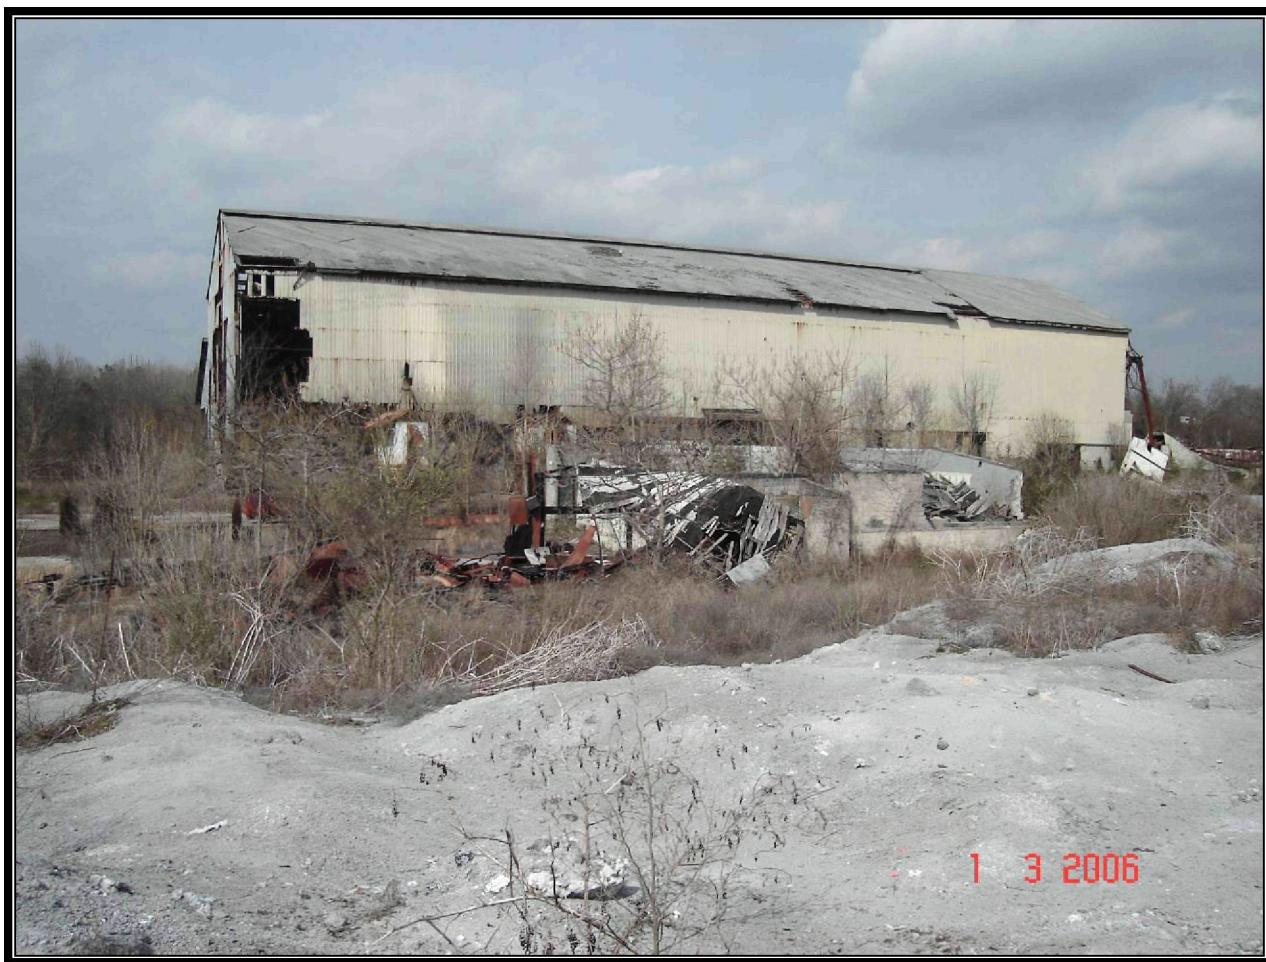
**OFFICIAL PHOTOGRAPH No. 12**  
**U.S. ENVIRONMENTAL PROTECTION AGENCY**

<b>TDD Number:</b>	TTEMI-05-003-0001	<b>Location:</b>	Smokey Mountain Smelters
<b>Orientation:</b>	Northeast	<b>Date:</b>	March 1, 2006
<b>Photographer:</b>	Sandra Harrigan, Tetra Tech	<b>Witness:</b>	Loften Carr, EPA
<b>Subject:</b>	Exterior waste pile. The foreground of the picture contains grey material (aluminum dross or salt cake). The process building is visible in the background.

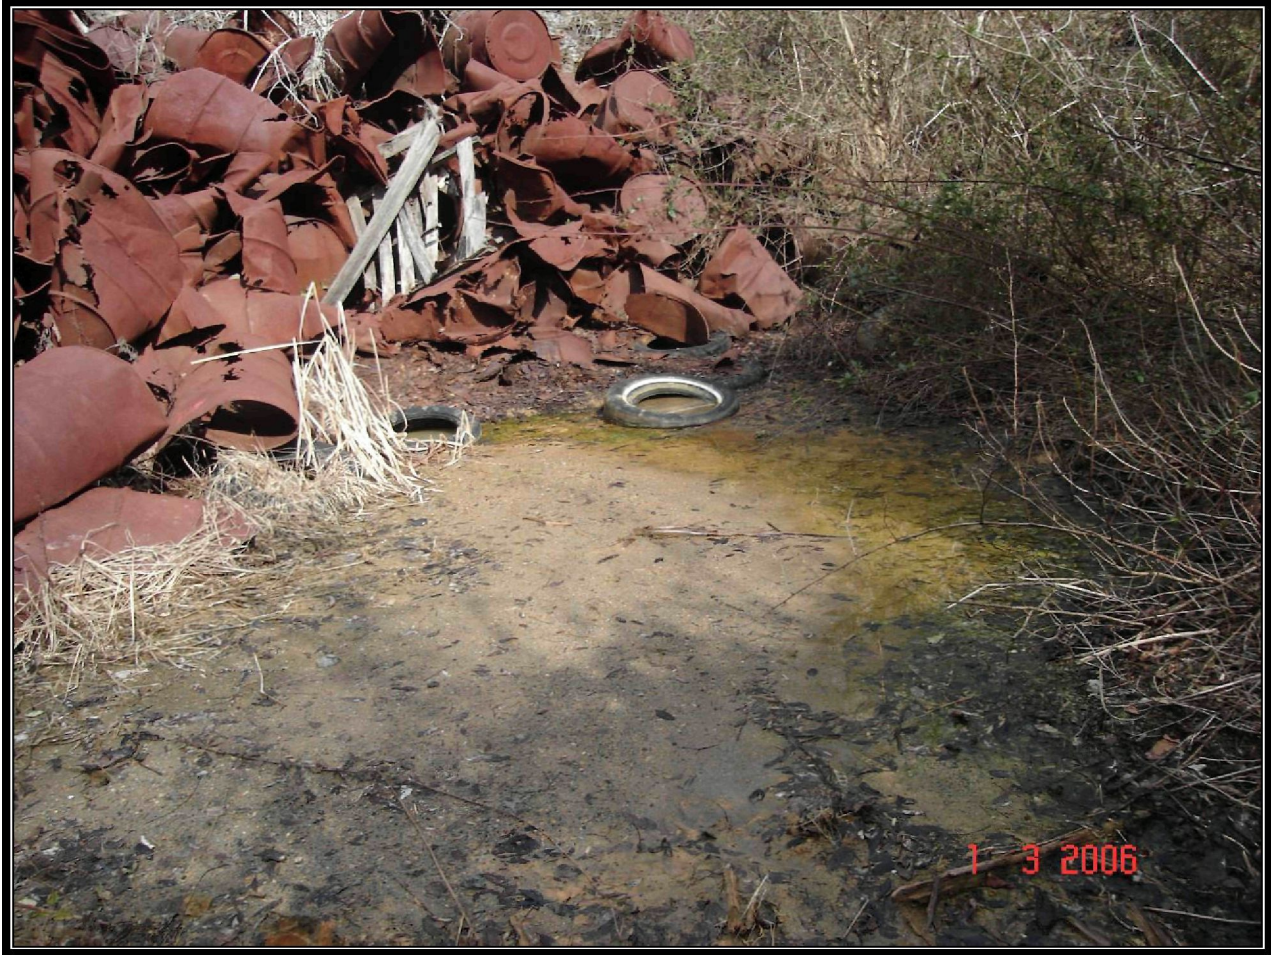
**OFFICIAL PHOTOGRAPH No. 13**  
**U.S. ENVIRONMENTAL PROTECTION AGENCY**

- There was a pile of drums located at the southwestern corner of the exterior waste pile. A leachate seep was observed emanating from the exterior waste pile in this area. The leachate seep flowed from to an unnamed perennial tributary of the East Branch of Flenniken Branch.

<b>TDD Number:</b>	TTEMI-05-003-0001	<b>Location:</b>	Smokey Mountain Smelters
<b>Orientation:</b>	Northwest	<b>Date:</b>	March 1, 2006
<b>Photographer:</b>	Sandra Harrigan, Tetra Tech	<b>Witness:</b>	Loften Carr, EPA
<b>Subject:</b>	Pile of rusted drums located at the west-southwestern end of the exterior waste pile. Standing water from the leachate seep is visible in the foreground.

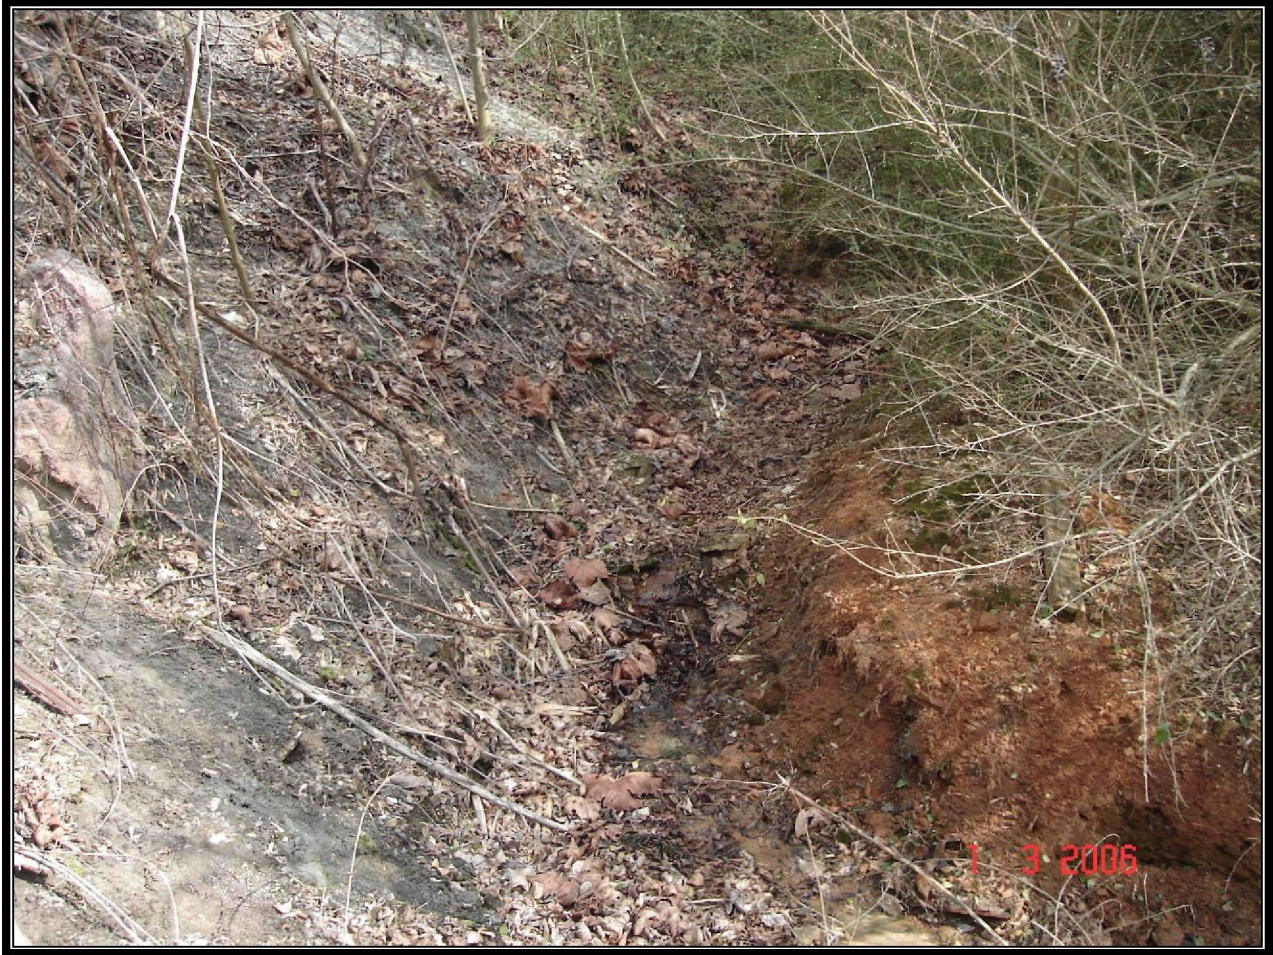
**OFFICIAL PHOTOGRAPH No. 14**  
**U.S. ENVIRONMENTAL PROTECTION AGENCY**

- Another leachate seep was also observed emanating from the exterior waste pile east of the pile of drums. This second leachate seep also flowed to the unnamed perennial tributary of the East Branch of Flenniken Branch.

<b>TDD Number:</b>	TTEMI-05-003-0001	<b>Location:</b>	Smokey Mountain Smelters
<b>Orientation:</b>	Northeast	<b>Date:</b>	March 1, 2006
<b>Photographer:</b>	Sandra Harrigan, Tetra Tech	<b>Witness:</b>	Loften Carr, EPA
<b>Subject:</b>	Location of small leachate seep located at the southern end of the exterior waste pile. This location is east of the large pile of rusted drums and the larger leachate seep.

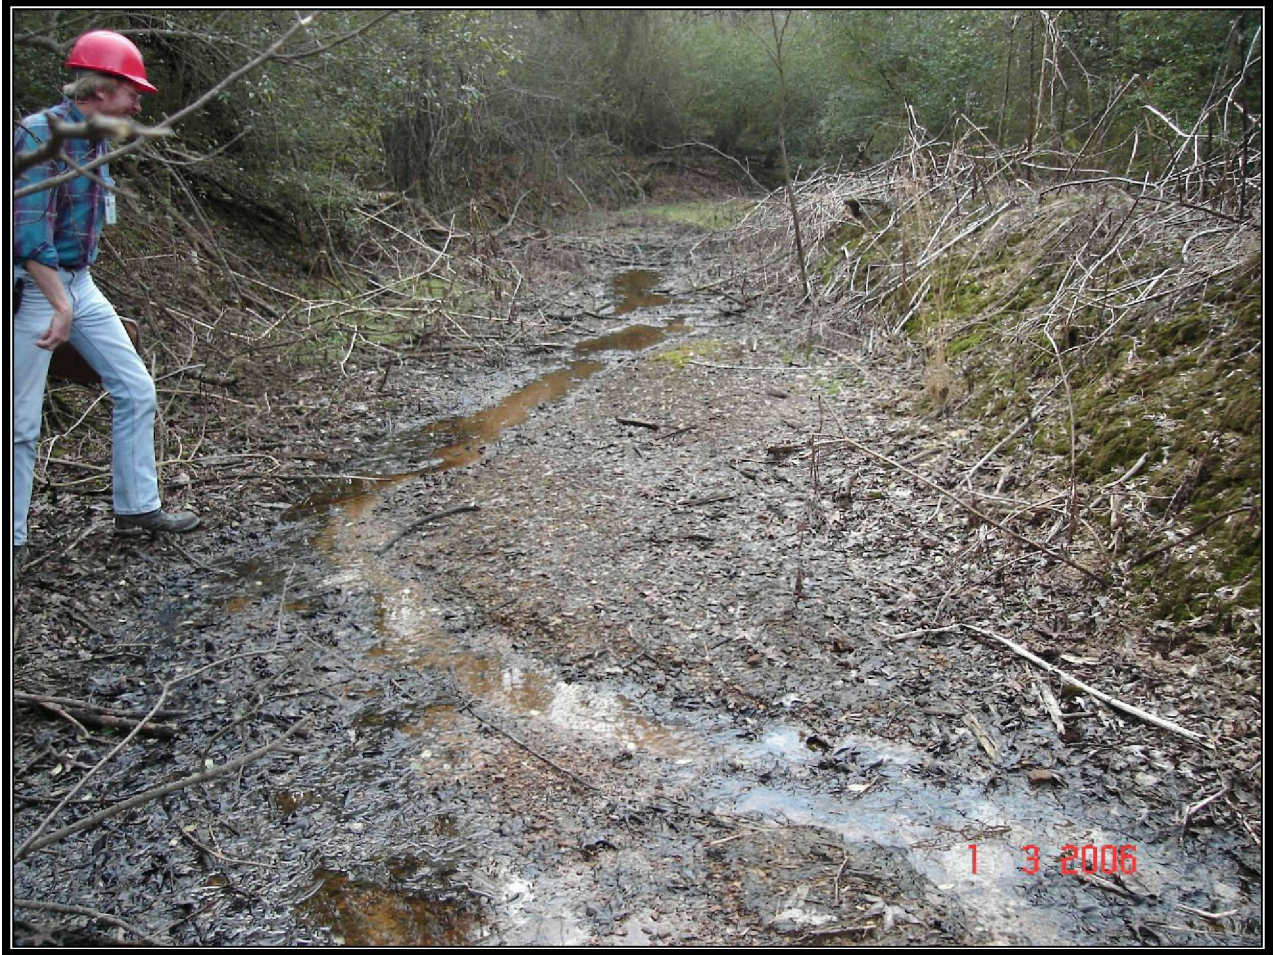
**OFFICIAL PHOTOGRAPH No. 15**  
**U.S. ENVIRONMENTAL PROTECTION AGENCY**

- During the reconnaissance, an engineered and maintained runoff management system to prevent the leachate seeps from entering the on-site unnamed perennial tributary of the East Branch of Flenniken Branch was not present. Also, no maintained engineered cover, functioning and maintained run-on control system, and run-off management system were in place to contain surface water runoff from the interior and exterior waste piles.

**Subject:** Probable point of entry where the leachate seep (west southwestern end of the exterior waste pile) enters the on-site unnamed perennial tributary of the East Branch of Flenniken Branch.

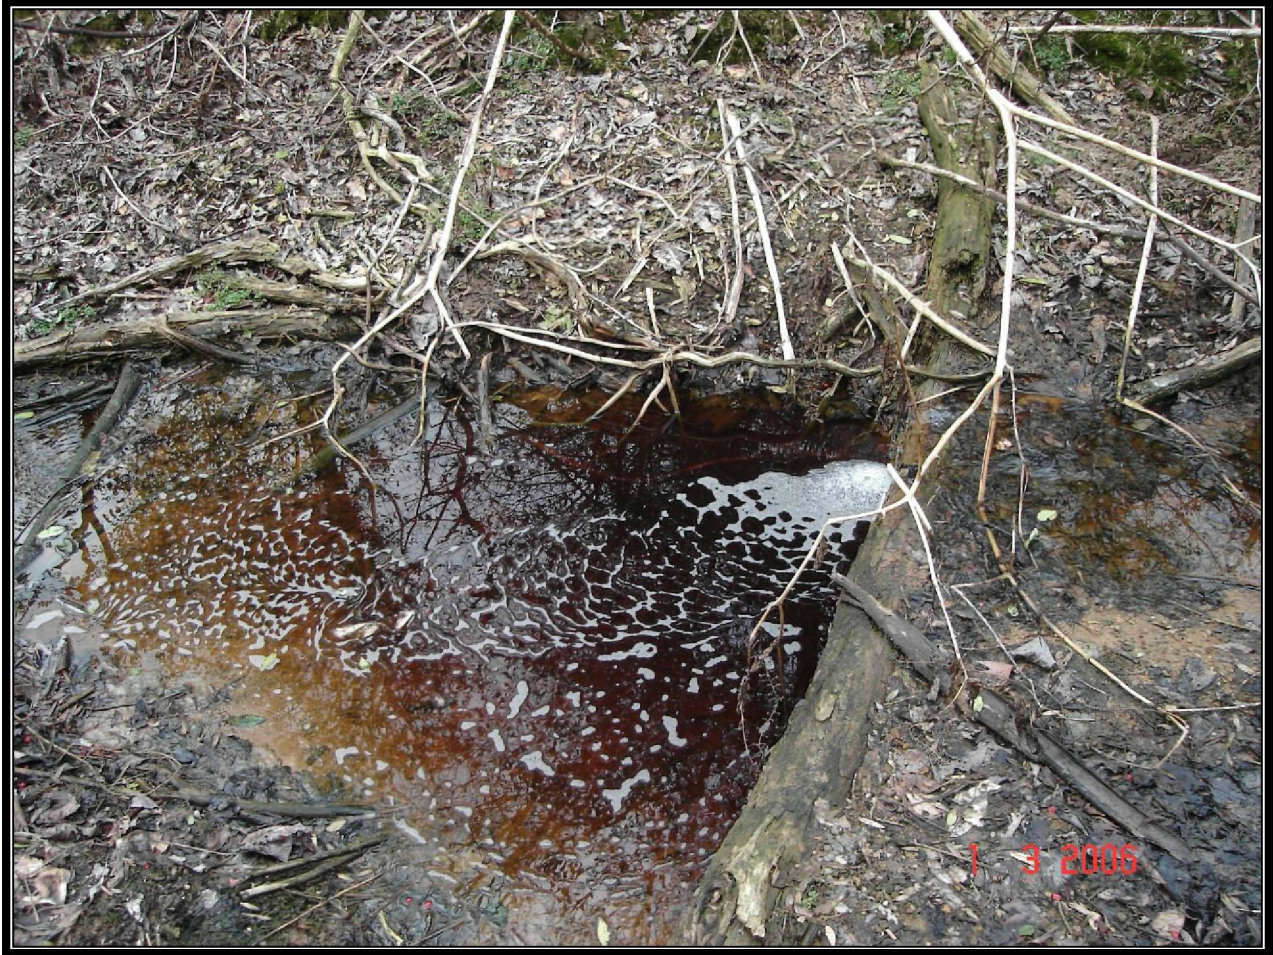
**OFFICIAL PHOTOGRAPH No. 16**  
**U.S. ENVIRONMENTAL PROTECTION AGENCY**

<b>TDD Number:</b>	TTEMI-05-003-0001	<b>Location:</b>	Smokey Mountain Smelters
<b>Orientation:</b>	East	<b>Date:</b>	March 1, 2006
<b>Photographer:</b>	Sandra Harrigan, Tetra Tech	<b>Witness:</b>	Loften Carr, EPA
<b>Subject:</b>	On-site unnamed perennial tributary of the East Branch of Flenniken Branch, just downstream of the leachate seeps.
